S. Van Baars¹

Peat Dike Failure in the Netherlands

Abstract

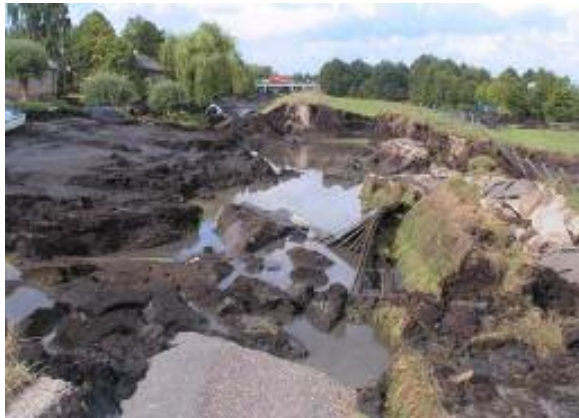
Fig. 1. Canal (left) and dike(right)

Figure 1. shows the empty canal on the left and the dike on the right. Figure 2. shows the dike after failure. About 50 meter of dike was shifted towards the north (left of the picture), leaving two breaches through which the water from the canal streamed into a lower quarter of the village Wilnis, 30 km Southeast of Amsterdam.

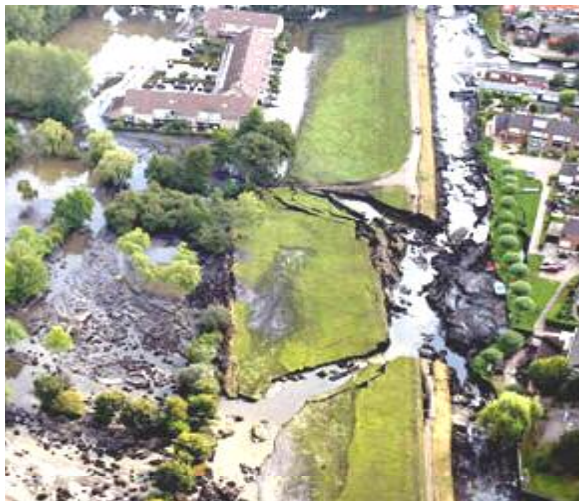
Fig. 2. Shifted part of a canal dike

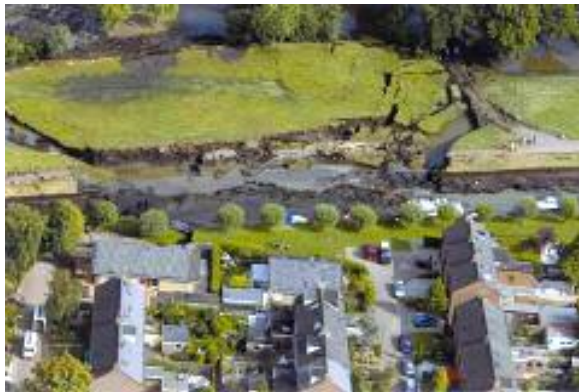
Fig. 5. Shifted part north-dike

In the night of Monday on Tuesday August 26th, at 1:30 h, more than 50 m of the secondary dike along the ring canal near Wilnis was translated sideways over 15 m. Because of this, the water in the canal started to run, along both ends of the shifted dike part, into the new housing quarter Veenzijde.

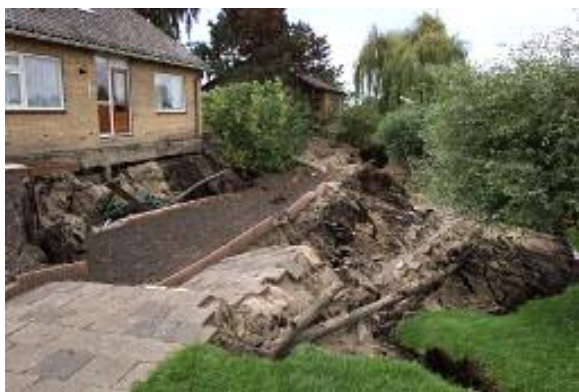
Fig. 6. Circular slip surface failure of the south-quay

Fortunately, a local contractor immediately started to close off both ends of the ring canal in the East and the West and a side canal in the South. By the time the ring canal was closed off with clay, which was immediately brought by other contractors, the 600 houses in Veenzijde were already half a meter under water. The 2000 residents were evacuated in the early morning. Almost all residents could return to their homes the same evening after the water was pumped out of this area. Because of the failure of the north-dike, the water level in the canal dropped instantly. Because of this the supporting horizontal water pressure on the south-quay disappeared, creating this quay to fail by a circular slip surface, see figure 6.

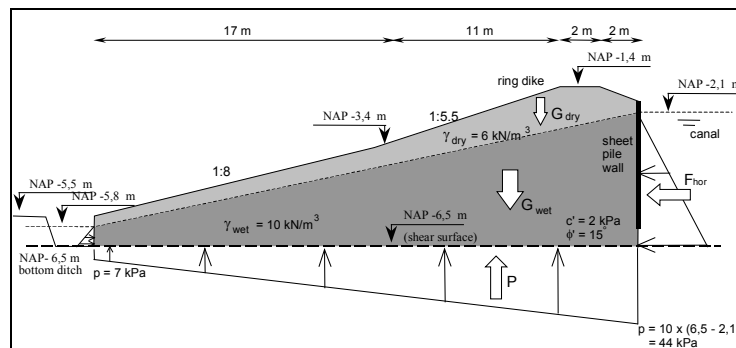
The failure mechanism of the dike is a horizontal pushing aside of the dike. The forces reacting on the dike and sizes are more or less as shown in figure 7. The stability of this dike can be checked easily with a simple one page computation.

Fig. 7. Cross section and failure mechanism

In figure 7, the total cross section of the dike above the horizontal slip surface is $I_{tot} = 99,85 \text{ m}^2$. The cross section of the peat below the diagonal freatic line is $I_{wet} = 81,6 \text{ m}^2$, so the part of peat which is able to dry out is: $I_{dry} = I_{tot} - I_{wet} = 99,85 - 81,6 = 18,25 \text{ m}^2$. The vertical uplifting water pressure P is identical to the weight of the wet part of the dike G_{wet} , since in this case the specific weight of peat is the same as the specific weight of water.

$$F_{hor} = \frac{1}{2} \times 10 \times [(6,5 - 2,1)^2 - 0,7^2] = 94,35 \text{ kN/m}$$

$$\begin{aligned} F_{\max} &= c' A + \tan(\phi') I_{\text{dry}} \gamma_{\text{wet}} \\ &= 2 \times 32 + 0.268 \times 8.25 \times 10 \\ &= 112.90 \text{ kN/m} \end{aligned}$$

$$f = 112,9 / 94,35 = 1.20$$

$$\begin{aligned} F_{\max} &= c' A + \tan(\phi') I_{\text{dry}} \gamma_{\text{dry}} \\ &= 2 \times 32 + 0.268 \times 8.25 \times 6 \\ &= 93,35 \text{ kN/m} \end{aligned}$$

$$f = 93.35 / 94,35 = 0.99$$

which explains the failure of the dike of Wilnis.

Interesting is that in this case about 2/3 of the maximum shear resistance is obtained from cohesion ($c' A = 2 \times 32 = 64 \text{ kN/m}$) and not from friction. This makes the dike in fact less sensible to mass reduction caused by drying out. So, the drying out was more like the last straw that broke the camels back, because the safety of the dike was already rather low.

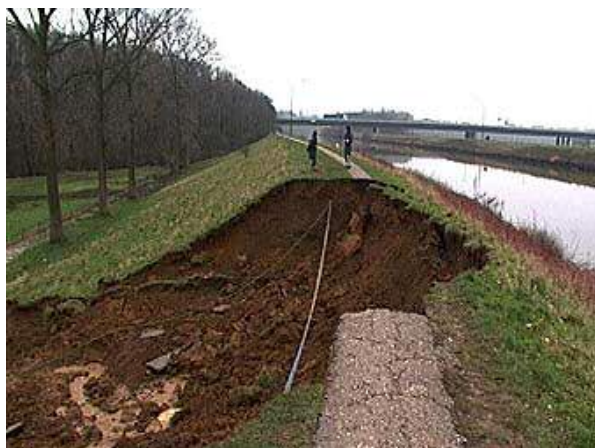
A good example is the failure of a canal dike in January 2004 near Stein, a town in the South-east of the country. A large part of the inner slope slided down, leaving only a very small part of dike between thousands of houses and the water of the canal. The water level was lowered 2 m immediately (see fig. 8). Still over time more and more water was streaming out of the gap. After several days working the amount of leaking water was not decreasing but increasing. The ministry of public works decided to install a sheet pile wall in the dike. By regulations all water pipes in the area were shut off before the installation. Immediately no more water was leaking out of the remaining dike part. A leaking water pipe was found right under the gap. This is not the first time the cause of a dike failure. Why then did nobody think of a leaking water pipe?

Fig. 8. Inner slope dike failure near Stein
