S. Van Baars¹

Peat Dike Failure in the Netherlands

Abstract

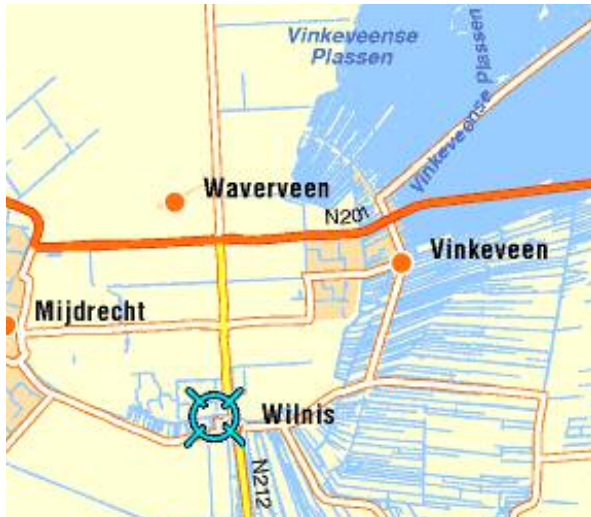
Fig. 3. Wilnis connected with the lake

The village Wilnis is part of the community "Ronde Venen" (Round Peats). It is about 30 km Southeast of Amsterdam. There is a ring canal which goes from the lake near Vinkeveen, through Wilnis, towards the city Mijdrecht (Figure 3). The old part of Wilnis is South of the ring canal. The new housing quarter, named "Veenzijde" (Peat-side) is the square of land North of the ring canal.

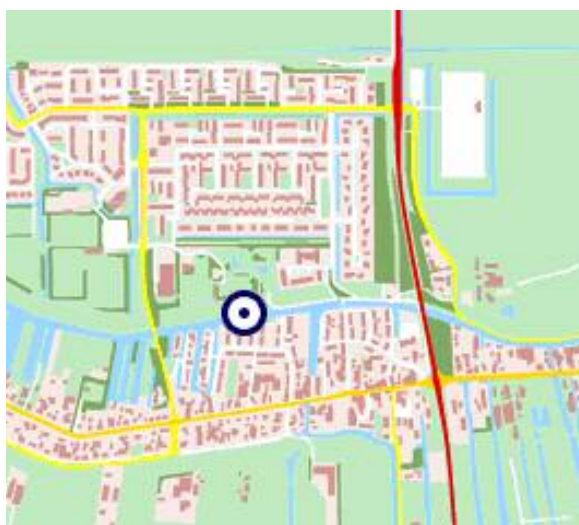
Fig. 4. Wilnis along the ring canal

In figure 4, a dot marks the location of the dike failure. The new housing area Veenzijde is North of this dot and is one of these excavated peat areas. The secondary ring dike between Veenzijde and the canal is not like most of the Dutch dikes man-made, but is a left-over from the peat-excavation. The area south of the ring canal is not excavated and is therefore as high as the failing ring dike on the other side. The ring dike is the only barrier between 10 square km of water of the "Vinkeveense plassen" (Finch-Peat's Lakes).
